# Manhole Inspection Summary

Manhole # S23AA2006MH

Insp Date: **5/2/07 12:51 PM**

**Location** Address: **5400 NORTHERN PKWY**

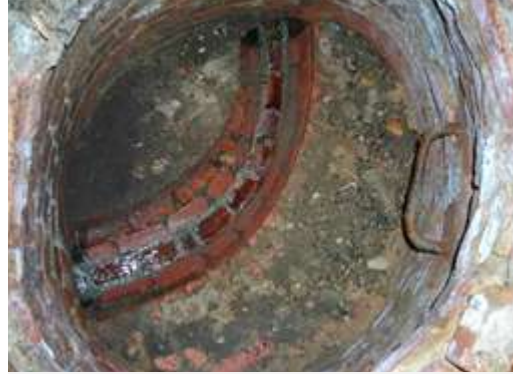
Top View

Corroded steps. Evidence of surcharge - Bench debris.

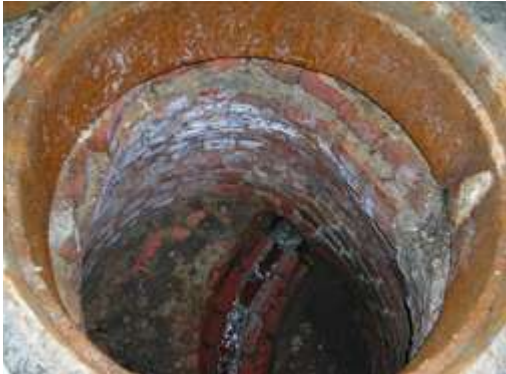
Defect

Adjustment deterioration and infiltration. Corbel and Barrel infiltration.

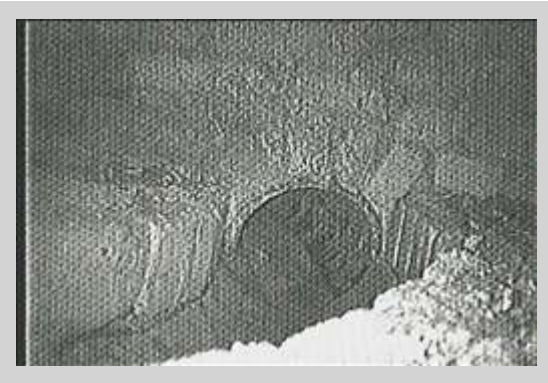
### 8 in. Circular Gravity Sewer Pipe Out @ 12 O'Clock

Barrel deterioration and infiltration. Channel deterioration.

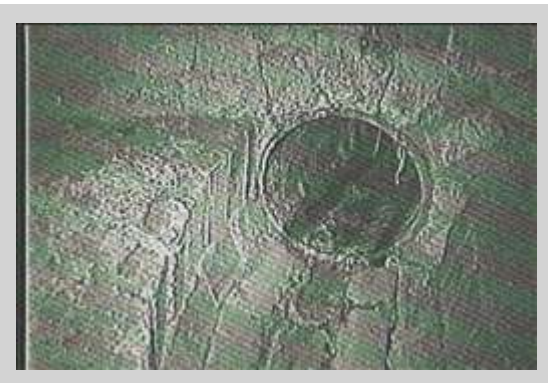
### 8 in. Circular Gravity Sewer Pipe In @ 8 O'Clock

Barrel deterioration and infiltration. Channel deterioration.
